**The Measured Performance of Aluminized Type 2 Steel Pipe
in Storm Sewer Applications in the North Georgia Region**

Field Performance of Aluminum Coating on Aluminized Type 2 Steel Pipe in the Atlanta Metro Area

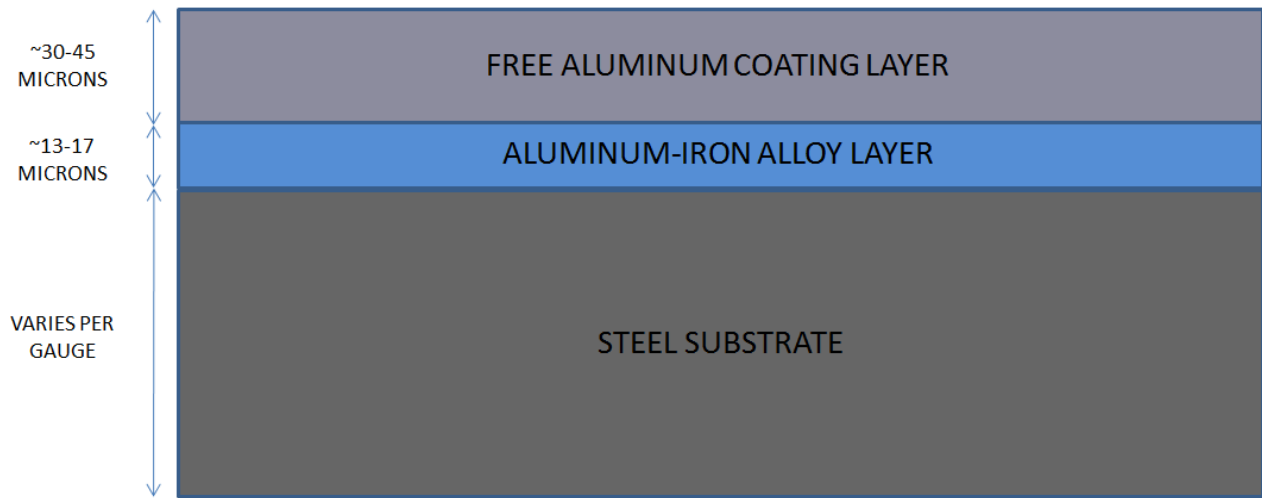
The protective coating of aluminized type 2 corrugated steel pipes is composed of a free aluminum surface layer and an aluminum-iron alloy layer that protects the steel substrate from exposure to the surrounding environment and the abrasion forces of flowing water.

The gauges used in this study measured the overall thickness of the steel pipe as well as the free aluminum coating layer. The aluminum-iron alloy layer was not directly measured, but was estimated using the known thicknesses of these layers from decades of metallographic analysis.

The aluminum-alloy layer is typically 1/3 of the thickness of the free aluminum layer, but is much more chemically stable and over twice as hard as the free aluminum layer. Because the durability characteristics of the alloy layer are more than twice as resistant to wear compared to the free aluminum layer, a 2x factor could be assumed to extrapolate from the free aluminum wear rate. A reasonable add-on factor for the alloy layer would be 66% of the free aluminum layer service life ($1/3 \times 2 = 66\%$), but a 50% add-on factor was used to remain very conservative. The chart on the following pages is based on the measured free aluminum wear rate and the 50% add-on for the aluminum alloy layer, but it does not include the substantial service life provided by the steel substrate itself after the aluminized coating is depleted.

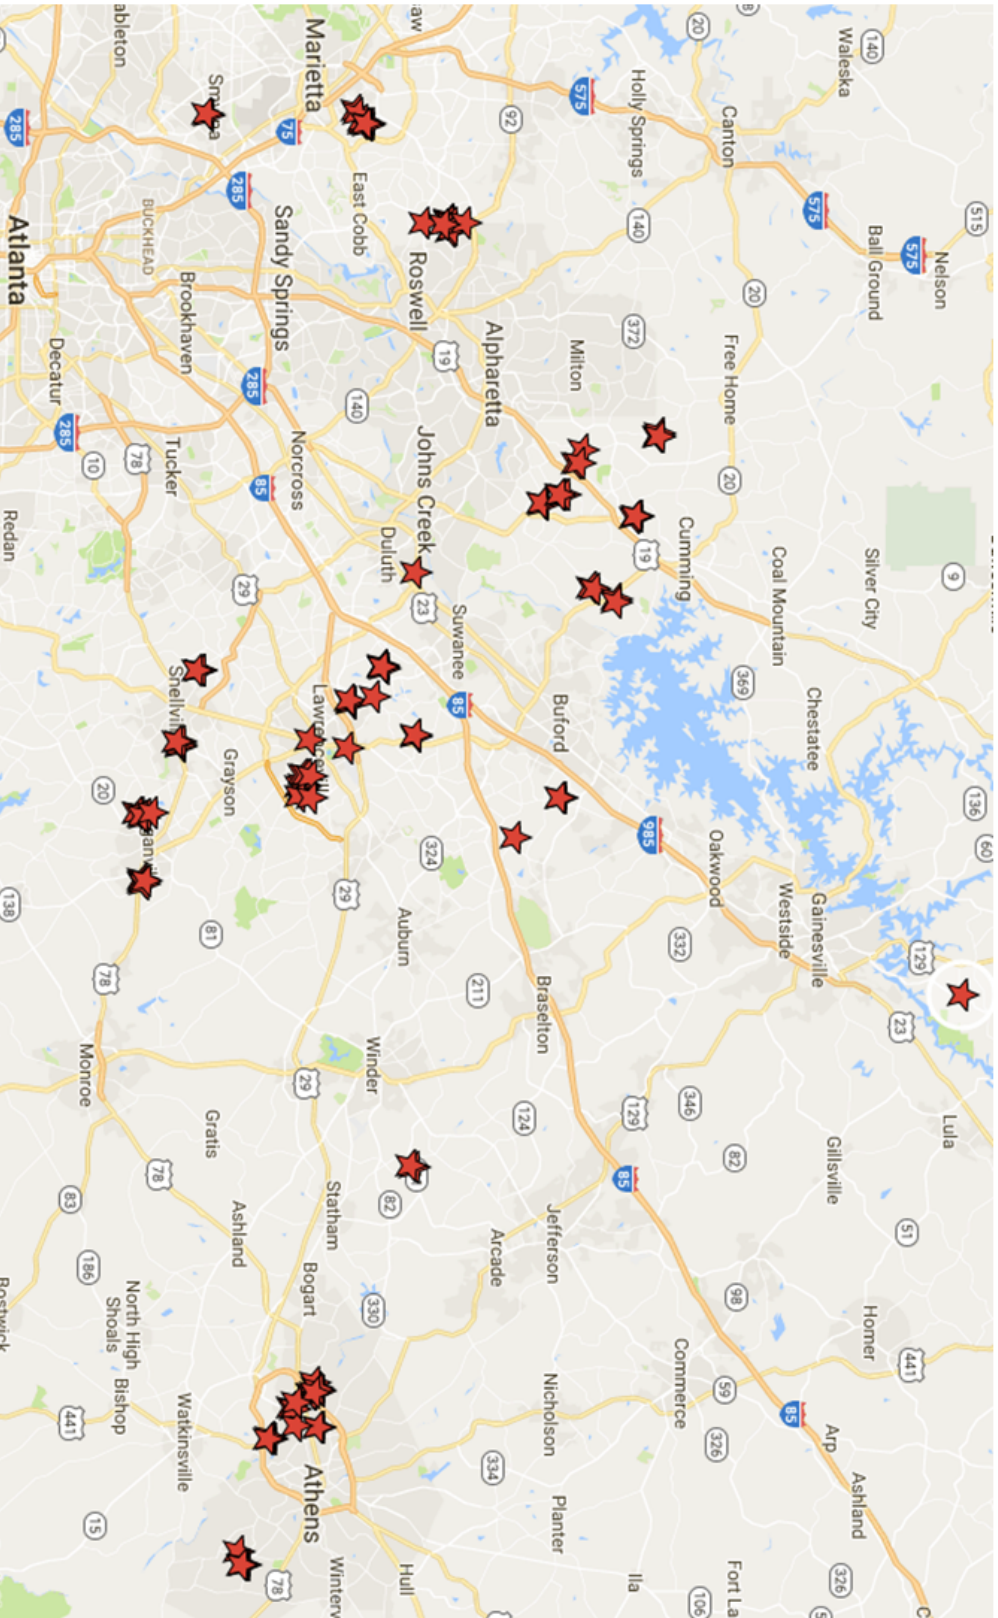
105 Aluminized Pipes Included in the Database Oldest pipe installation – 38 years, Average Age – 20 years

Database Includes Sites in :
Gwinnett (38), Athens-Clarke (20), Forsyth (19), Cobb (18), Walton (4) Hall (3), and Barrow (3)

The study includes 105 pipes located in Gwinnett, Cobb, Forsyth, Hall, Barrow, Athens-Clarke, and Walton counties. The oldest pipe in the study group is 38 years old and the average age of the pipes is 20 years. All of the pipes were tested and documented per the NCSIPA’s “Non-Destructive Testing Protocol for Corrugated Metal Pipe.”

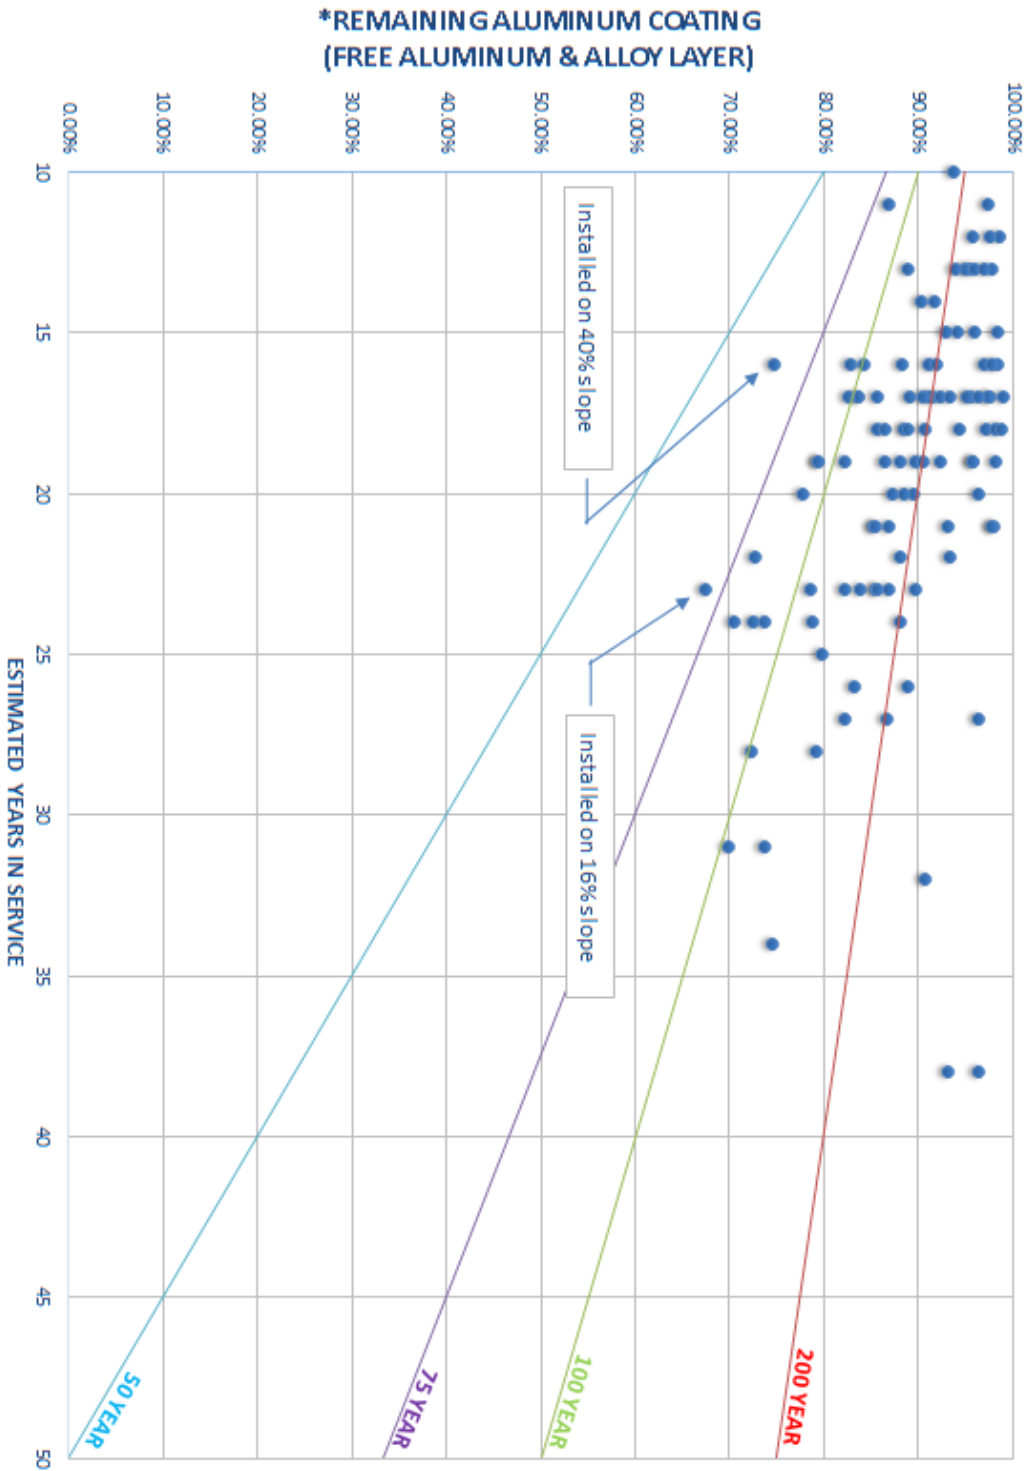
*Does not include substantial additional years of service life provided by the steel pipe structure itself

The average measured loss rate of the free aluminum layer found in the study was 0.84% per year. **At that rate, a piece of pipe installed today would still have significant aluminum coating after 100 years.** This wear rate only accounts for the surface free aluminum layer of and does not include the aluminum-iron alloy layer or the base steel itself. These second and third layers of material will provide substantial additional service life after the free aluminum is depleted.

This wear rate does not vary significantly across the sample based on the age of the pipes. For pipes that have been installed for 30 years or more, the measured wear rate is 0.78% per year, which is practically identical to the overall average for all the pipes in the study.
