**The Measured Performance of Aluminized Type 2 Steel Pipe
in Storm Sewer Applications in the North Georgia Region**

**Field Performance of Aluminum Coating on Aluminized Type 2 Steel Pipe
in the Atlanta Metro Area**

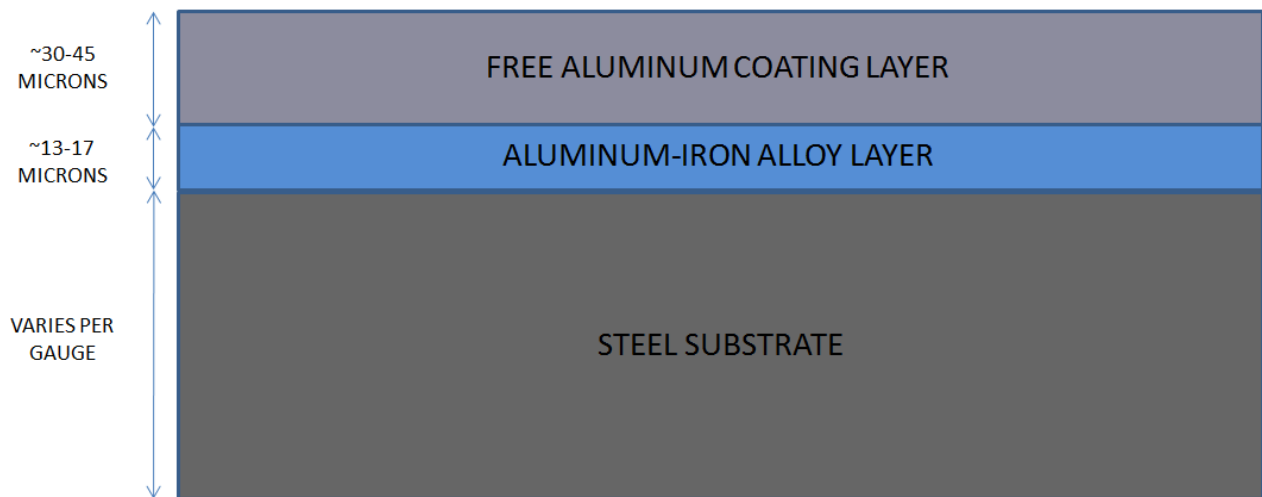
The protective coating of aluminized type 2 corrugated steel pipes is composed of a free aluminum surface layer and an aluminum-iron alloy layer that protects the steel substrate from exposure to the surrounding environment and the abrasion forces of flowing water.

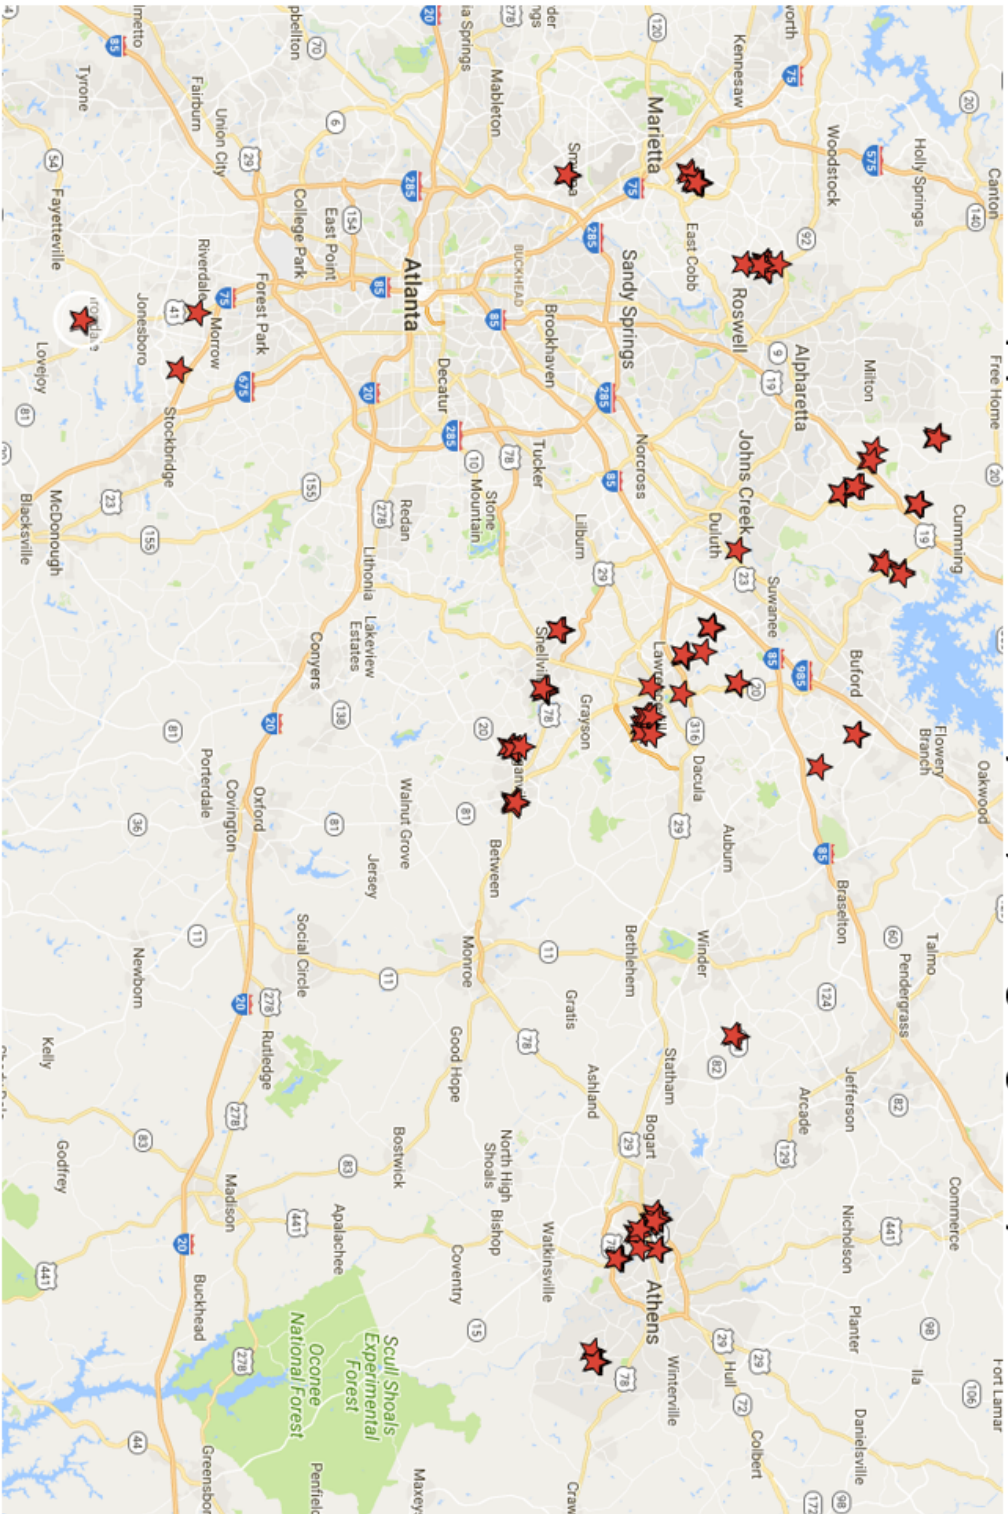
110 Aluminized Pipes Included in the Database Oldest pipe installation – 38 years, Average Age – 20 years

Database Includes Sites in : Gwinnett (38), Athens-Clarke (20), Forsyth (19), Cobb (18), Clayton (5), Walton (4) Hall (3), and Barrow (3)

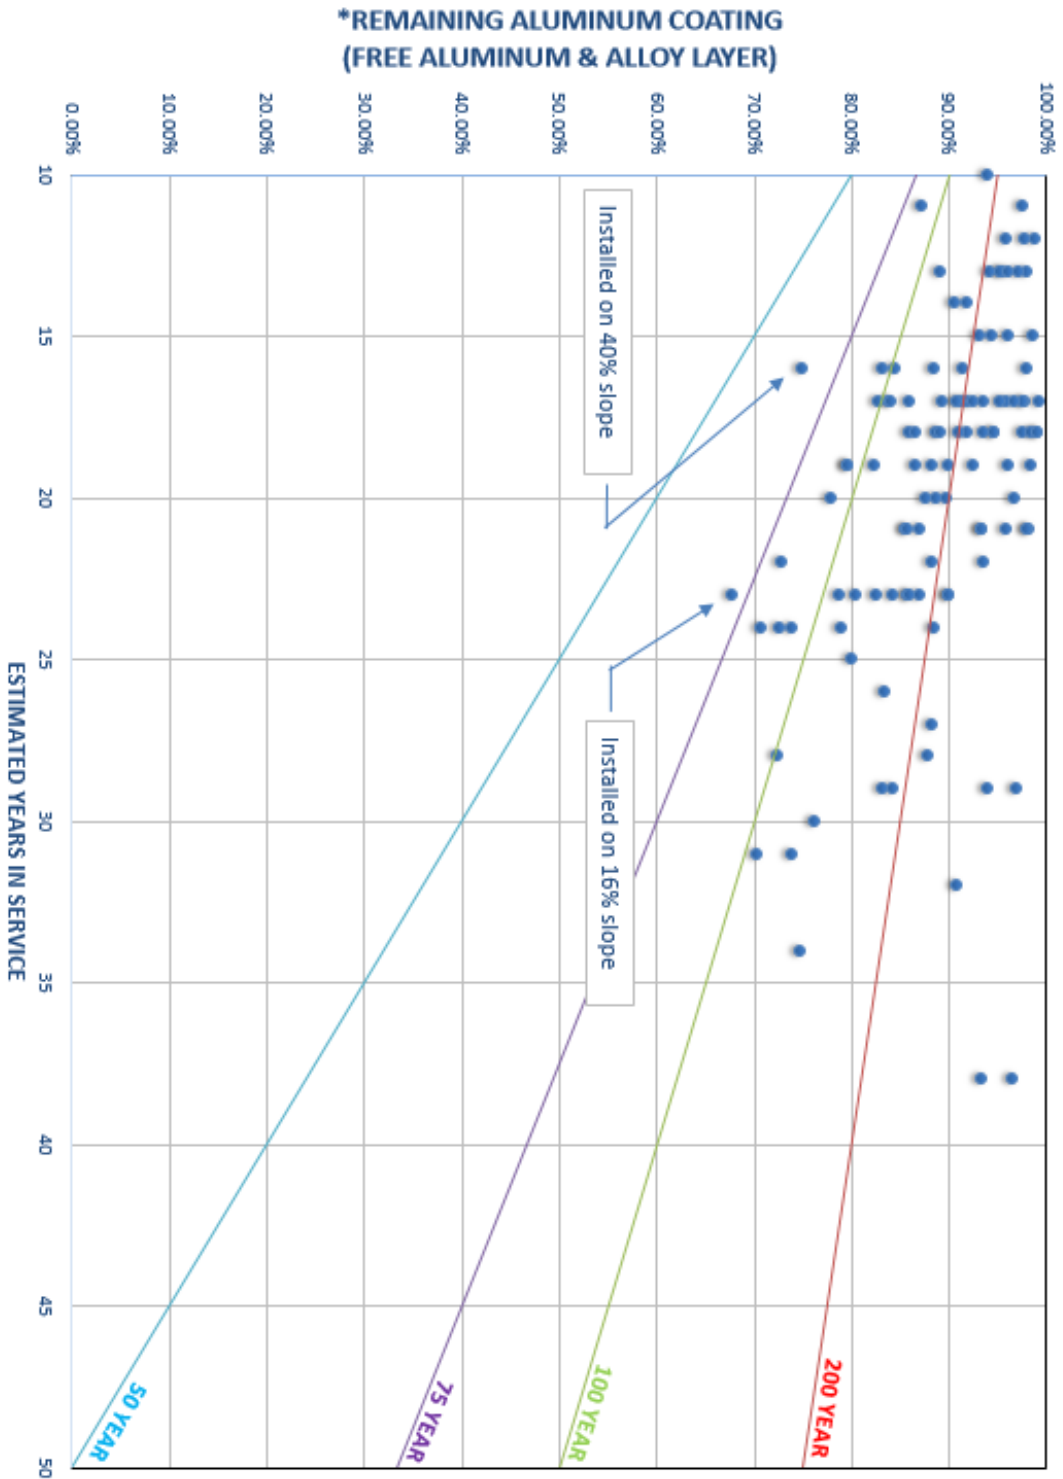
The average measured loss rate of the free aluminum layer found in the study was 0.83% per year. **At that rate, a piece of pipe installed today would still have significant aluminum coating after 100 years.** This wear rate only accounts for the surface free aluminum layer of and does not include the aluminum-iron alloy layer or the base steel itself. These second and third layers of material will provide substantial additional service life after the free aluminum is depleted.

*Does not include substantial additional years of service life provided by the steel pipe structure itself
